# Manhole Inspection Summary

Manhole # S13AA\_018MH

Insp Date: **11/13/07 2:59 PM**

**Location** Address: **912 PROSPECT ST**

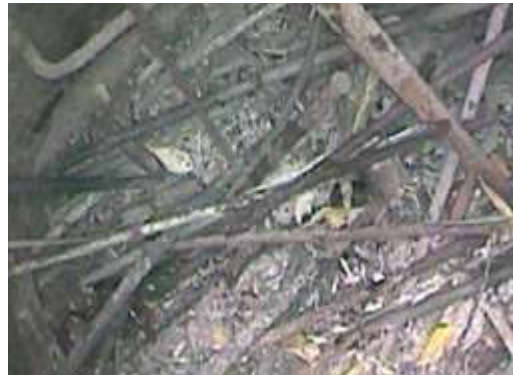
Top View

Condition: ☐ Sound ☐ Cracked ☐ Root Intrusion ☐ Deteriorated ☐ Leaks ☒ **Debris**

DEBRIS.

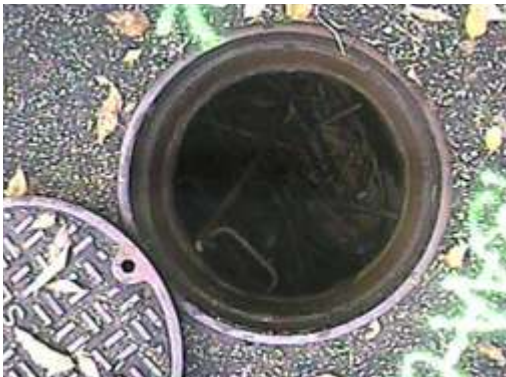
Top View

OFFSET

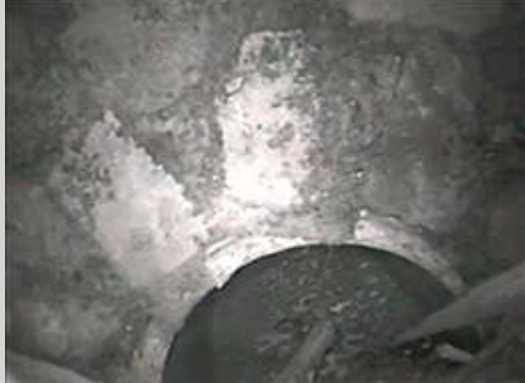
12 O'Clock Outflow

8 in. Circular Gravity Sewer  
Pipe Out @ 12 O'Clock

Deposits: ☐ None ☐ Mud ☐ Sludge ☒ **Debris** ☐ Grease

Silt Depth: **4** (in.) Deposits Extent: **Medium**
